Manhole Inspection Summary

Manhole # S130__023MH

Insp Date: **3/24/08 9:07 AM**

Location Address: **424 Font Hill AV**

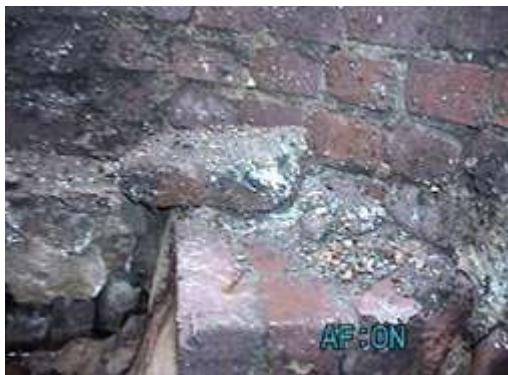
misc-1

debris on bench

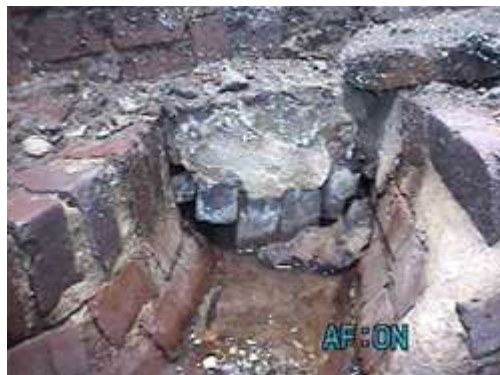
Pipe in @4 abandoned pipe

abandoned 3 oclk

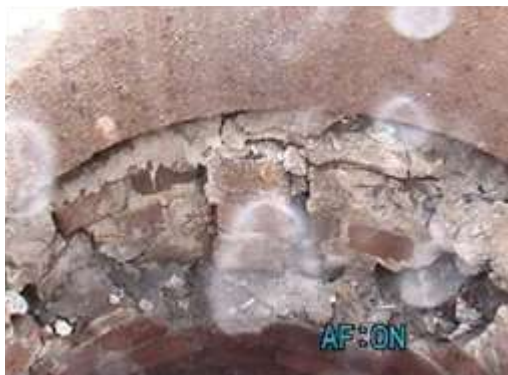
Defect 7

Condition: ☐ Sound ☐ Cracked ☐ Root Intrusion ☒ **Loose Brick** ☒ **Deteriorated**

Infiltration: ☐ None ☐ Joint ☐ Cracks ☒ **Mortar** ☐ Roots ☒ **Wall**

loose missing bricks, deteriorated chimney

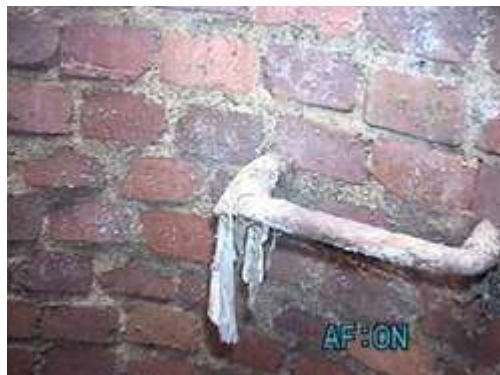
Defect 6

Steps Count: **3** Missing: **0** ☒ **Corroded**

Surcharge ☒ **Evidence Of Surcharge** Depth: **3** (ft.) ☐ Active Surcharge Present

rusted steps/ surcharge evidence

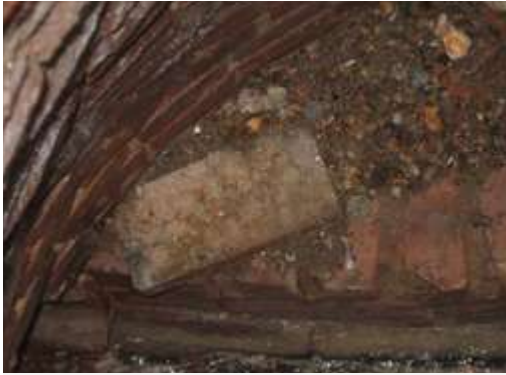
Defect 4

Condition: ☐ Sound ☐ Cracked ☐ Root Intrusion ☐ Deteriorated ☐ Leaks ☒ **Debris**

debris on bench

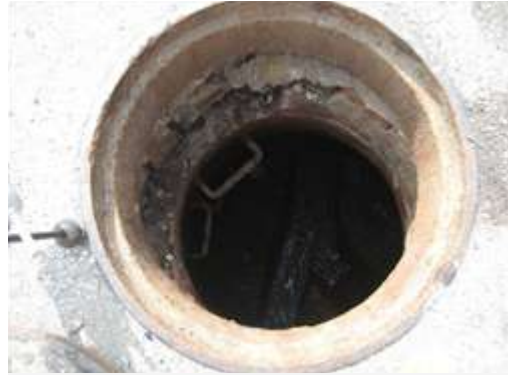
Defect 5

Frame Offset: **3** (in.) Condition: ☒ Sound ☐ Cracked ☐ Leaks

offset

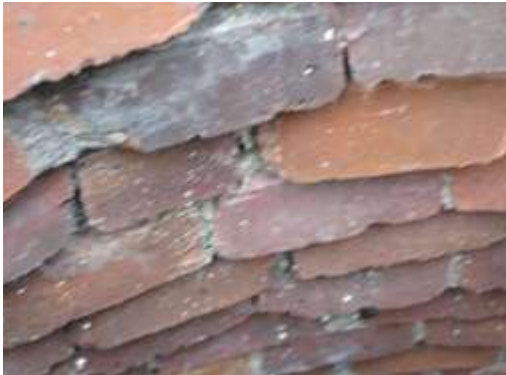
Defect 3

Condition: ☐ Sound ☐ Cracked ☐ Root Intrusion ☒ **Loose Brick** ☐ Deteriorated

loose bricks at corbel

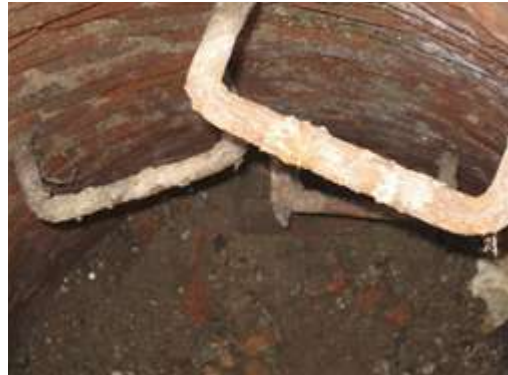
Defect 2

rusted rungs

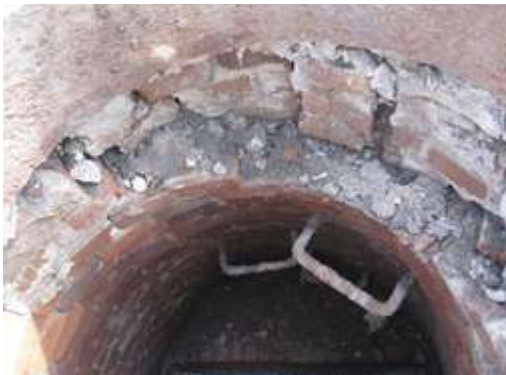
Defect 1

loose missing bricks sign of infiltration at chimney wall/mortar

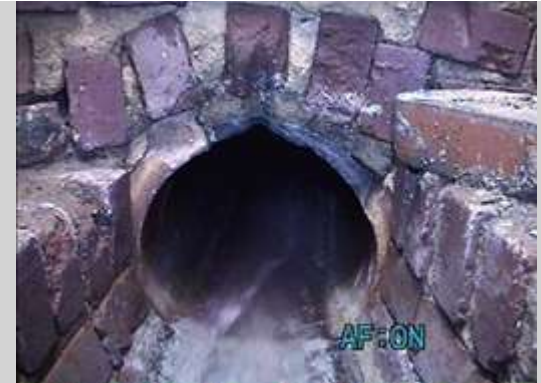
12 O'Clock Outflow

8 in. Circular Gravity Sewer
Pipe Out @ 12 O'Clock

Pipe Height: **8.4** (in.) Rod and Bar (Angled)
Pipe Material: **Clay** ☐ Pipe Lined
Invert Depth: **8.40** (ft.) Flow Characteristics: **Fast**
Deposits: ☒ None ☐ Mud ☐ Sludge ☐ Debris ☐ Grease
Silt Depth: **0** (in.) Deposits Extent:
Infiltration: **None** Pipe Seal Cond: **Sound**

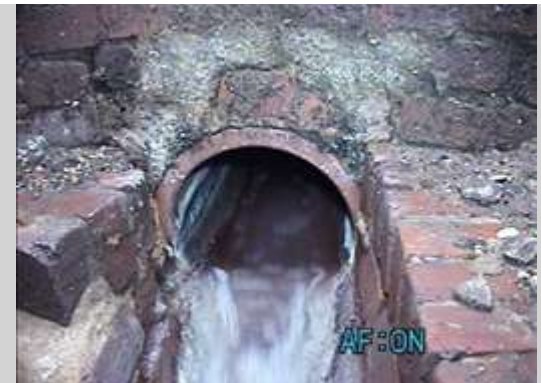
6 O'Clock Inflow

10 in. Circular Gravity Sewer
Pipe In @ 6 O'Clock

Pipe Height: **10.8** (in.) Rod and Bar (Angled)
Pipe Material: **Clay** ☐ Pipe Lined
Invert Depth: **8.32** (ft.) Flow Characteristics: **Fast**
Deposits: ☒ None ☐ Mud ☐ Sludge ☐ Debris ☐ Grease
Silt Depth: **0** (in.) Deposits Extent:
Infiltration: **None** Pipe Seal Cond: **Sound**
